Inspection Report

Prepared For John & Mary Smith

1234 M33, Alger, MI 48610

INSPECTION DATE	INFORMATION	
Inspection Date:	7/23/2023	Inspection Time :	1300
Buyers Agent:			
Company:

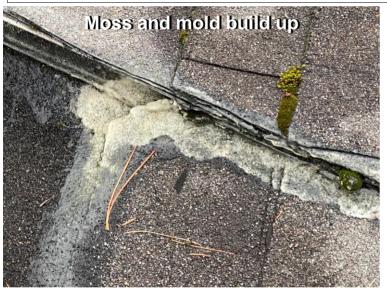
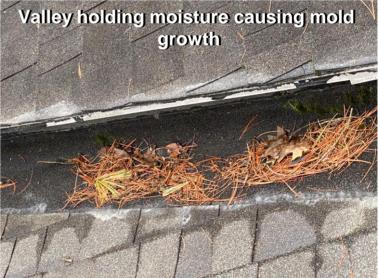
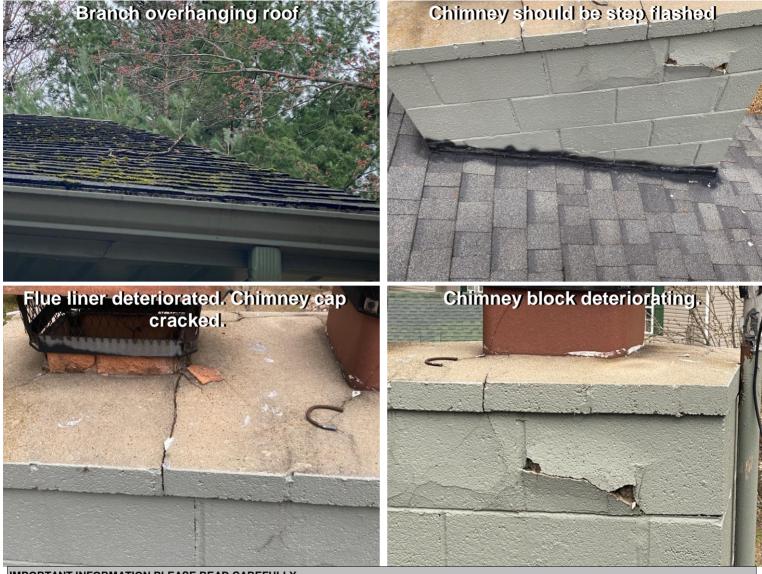
There was moss build up on much of the roof. Along with the damaged/Deteriorated concrete blocks near chimney cap. the chimney cap was cracked. The flashing at the chimney is improper. It should have step flashing.

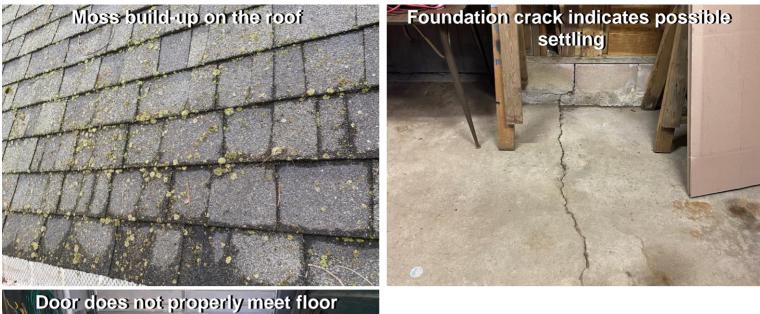
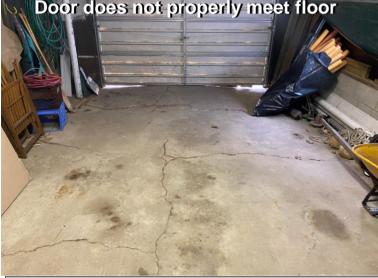
1. Roof Type Shingles - Composite		٦٢	Moss covered indicating a state of constant moisture. This will ultimately reduce th		
2. How_Viewed Walked					
3. Siding Material Metal

4. Trim Material Metal					
5. Framing Method Conventional Framing					
6. Floor Type Concrete			Crack(s) - Moderate. Floor slopes enough that there are oepnings between the doc

7. Finished Walls		x			
8. Finished Ceilings			Panels missing		
9. Windows					
10. Door 1 Type Over Head Door X			Door does not properly meet floor		
Location Front					
Material Fiberglass

16. Electrical					
17. Other Item					
18. Fire Wall		x	Could Not Verify Existance		
Additional Information					
There appears to be a settling crack on the North West foundation wall.

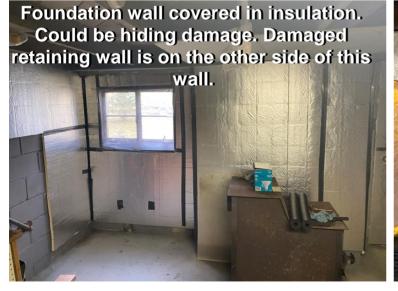
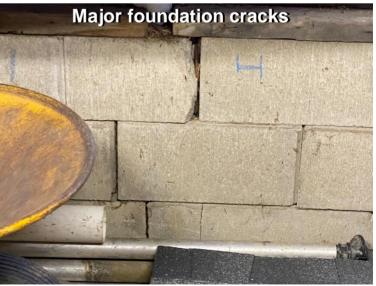
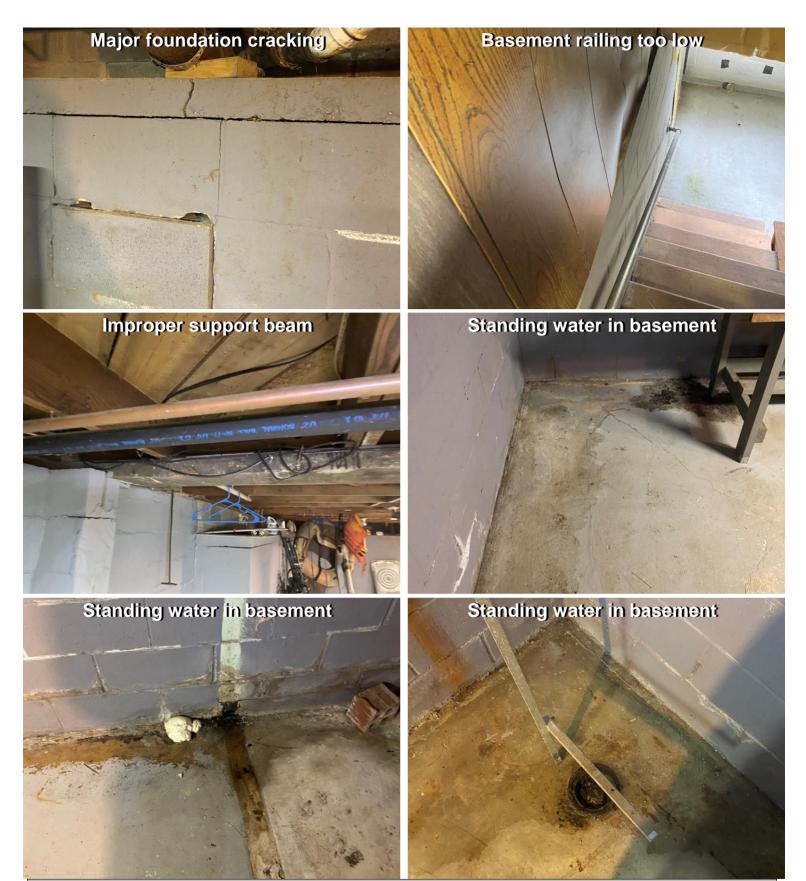
1.	Туре	Basement											
2.	How Viewed	Entered											
3.	Foundation	Brick / Block					X	The measurement from the finished basement floor to the first floor joists is 79 5/8"

4.	Door / Cover		X										
5.	Floor		X					Crack(s) - Minor					
6.	Windows					X		could not inspect function, as plastic is covering window.					
7.	Stairs		x					while functional, stairs are not up to current standards.

8.	Handrails			X				Railing(s) - Improper Height					
9.	Electrical			X				Missing GFCI Protection & 2 prong outlets. No GFCI protection.					
10.	Support Beam				х			Part of the basement has an iron beam. Part by stairs has improper support beam.

17.	Water penetration	on and dampness			X			Moisture_Noted					
Ade	ditional Informat	ion						1

The measurement from the finished basement floor to the first floor joists is 79 5/8". That is less than the standard 80" doorway.

There is an area of the foundation wall that is covered with insulation board. None of the other walls have this covering. This foundation wall is on the other side of the deteriorated retaining walls. I worry the insulation board could be covering foundation damage. Standing water all along South West wall. This correesponds to an area of improper grading on the font of the house. The main support beam rinning perpendicular to the basement stairs does not meet modern standards.

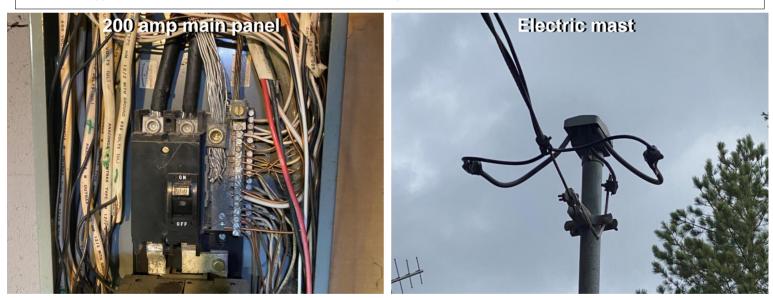
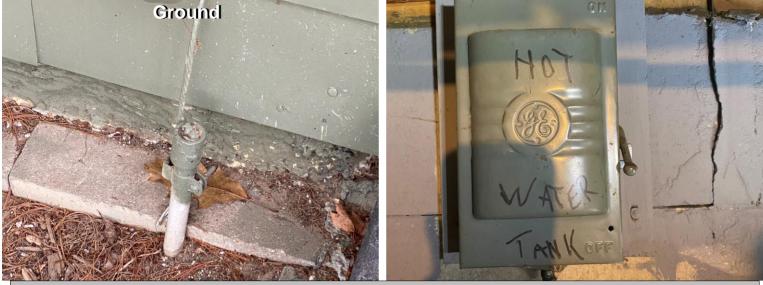
There is what appears to be an old water heater disconnect under the stairs adjacent to the water heater.

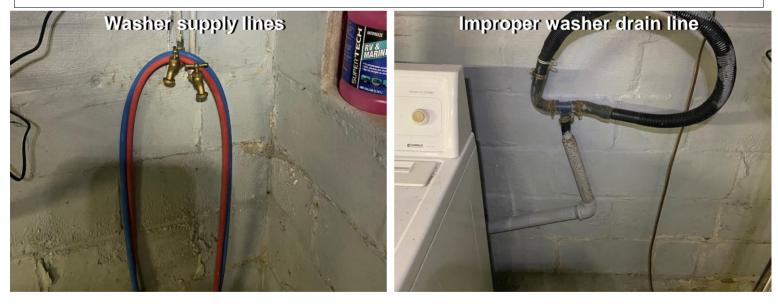
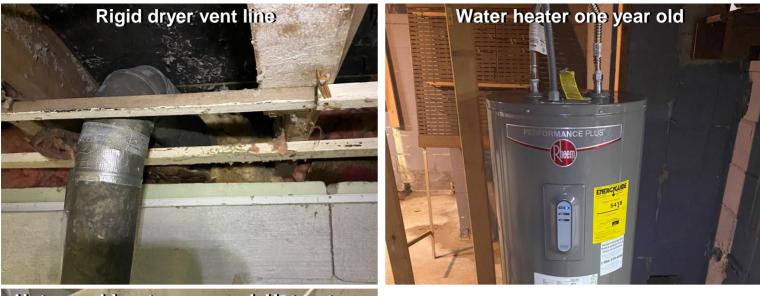
Hot and cold water lines are reversed on the basement laundry tub. The hot water ran for a short while, and then slowly stopped running. The cold worked well.

Hot an cold water reversed. Hot water slowed to a trickle.

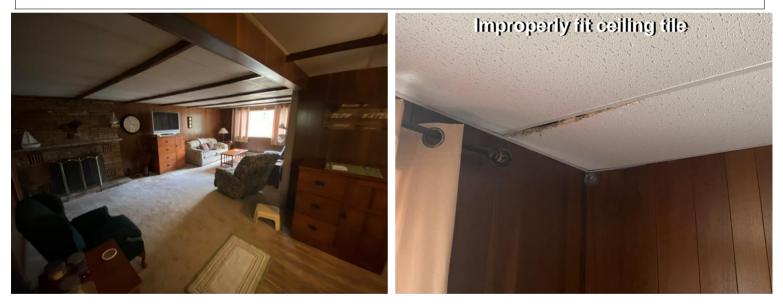
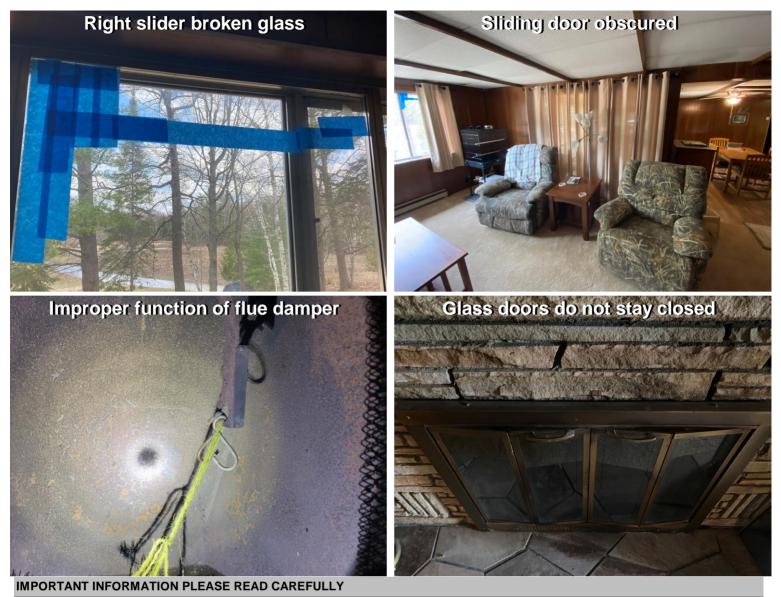
5. Windows		Х				Glass Broken in right slider. Left slider does not lock.						
6. Electrical	X					Receptacle(s) - 2 Prong Outlets						
7. Ceiling Fan(s)				X

8. Stairs / Railings		Π	Π	X								
9. Fireplace / Wood Stove		Х				Damper Damaged / Inoperative						
10. Smoke Detectors				X		Recommend Installation Of Smoke Detector(s)

10. Carbon Monoxide Detectors				X		Recommend Replacement Of CO Detector(s)						
11. Closet(s)	X											
dditional Information

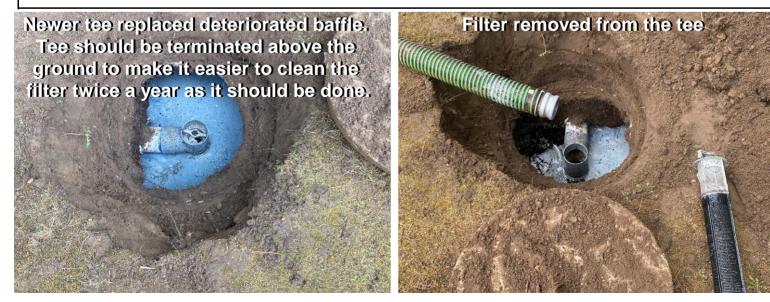
The septic system appears to be funtiioning properly. There is some dispute as to the size of the tank, but regardless, it appears adequately sized for the structure.

Installing a filter on a septic system limits solids from entering the drain bed. Wh

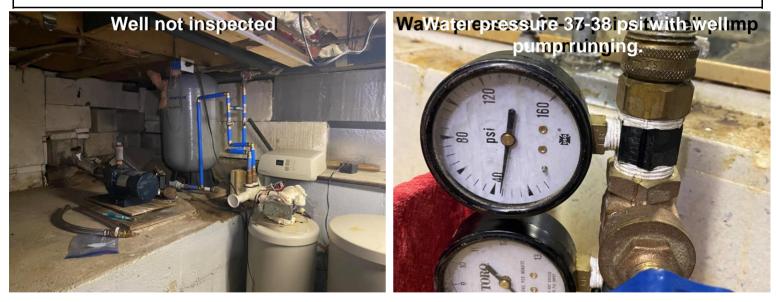
Flow rate 5 gpm-with pump running
